# **WESTERN AUSTRALIA TRUCK EXPLOSION INVESTIGATION**

## **CEAEC FALL MEETING – OTTAWA, CANADA**

## DMIRS Investigation Report – Key Points

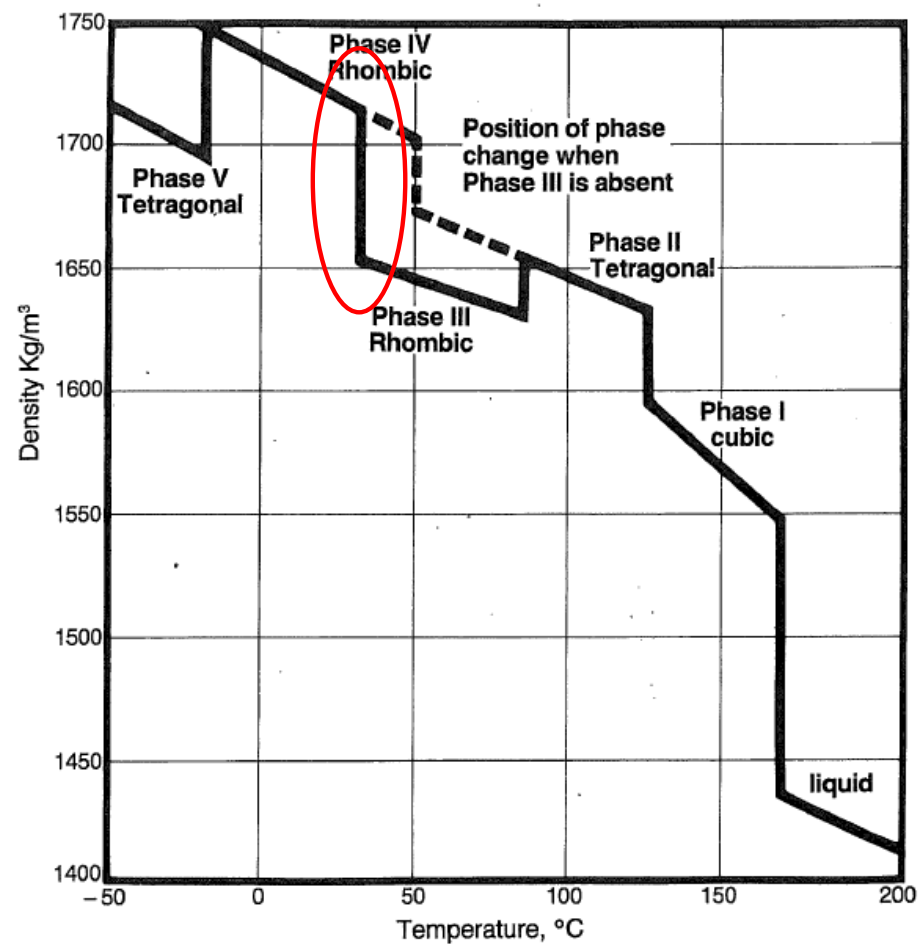
Fig. 1 Density changes in phase transitions of ammonium nitrate.  
(Data from Ref. 3.)

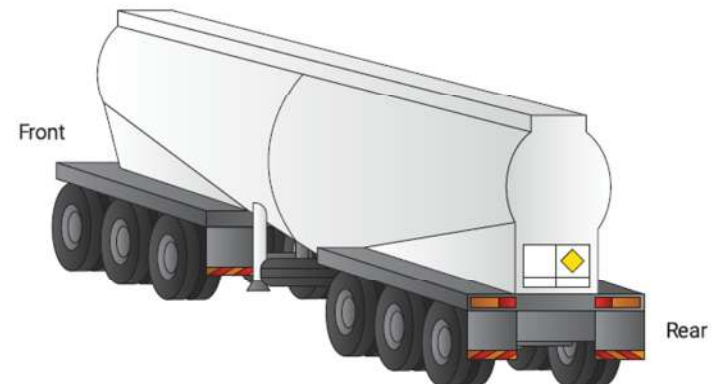
Figure 4.5 Representation of the tanker trailer, demonstrating the four tyres on each axle (12 at the rear and 12 under the dolly at the front)

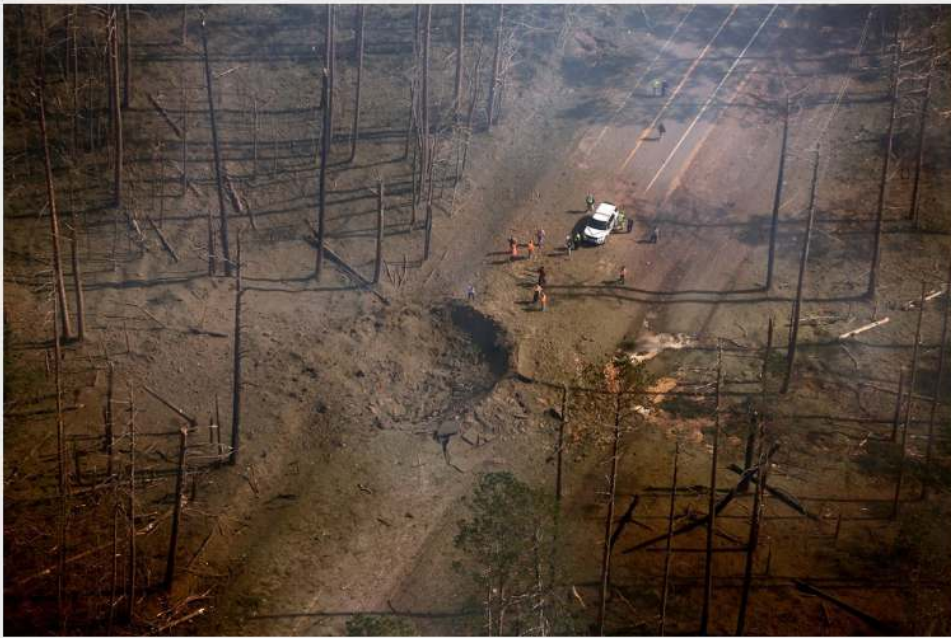
Aftermath: A crater sits on a portion of U.S. 278 west of Camden, caused by an explosion from a fertilizer truck on Wednesday. The driver of the truck was killed and the explosion could be heard miles away. Arkansas Democrat-Gazette/THOMAS METTHE

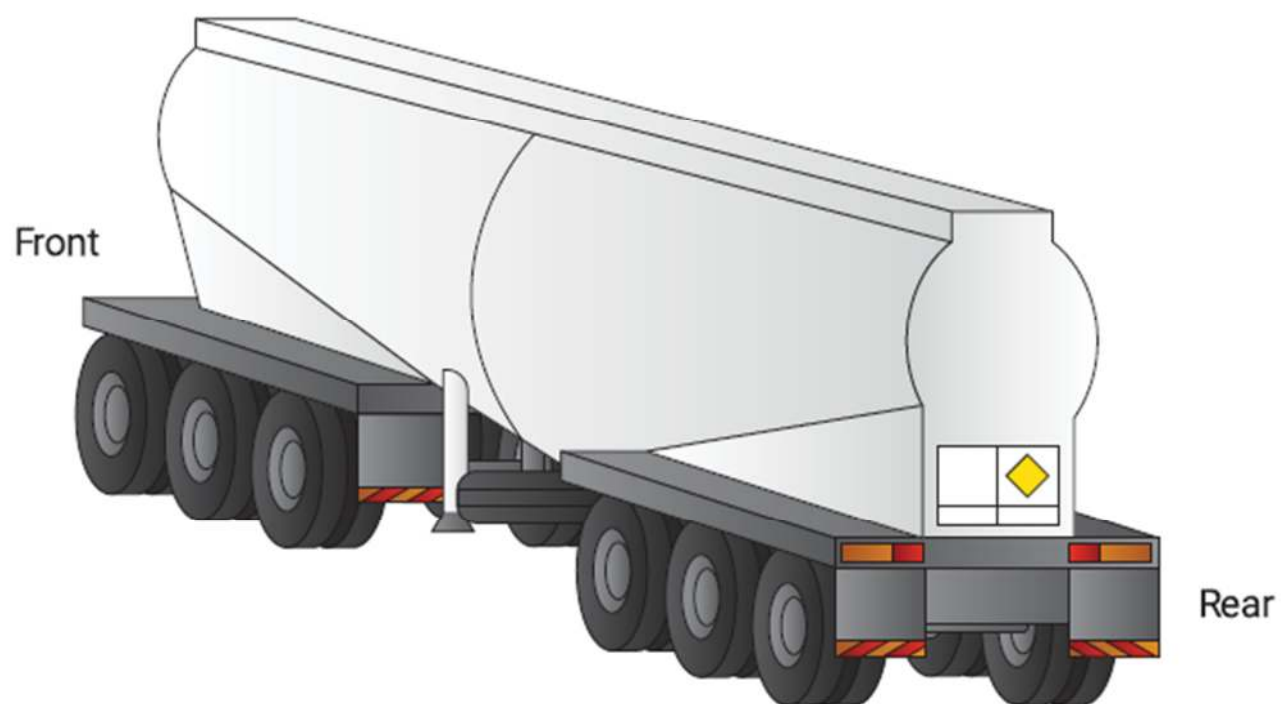
Figure 4.5 Representation of the tanker trailer, demonstrating the four tyres on each axle (12 at the rear and 12 under the dolly at the front)

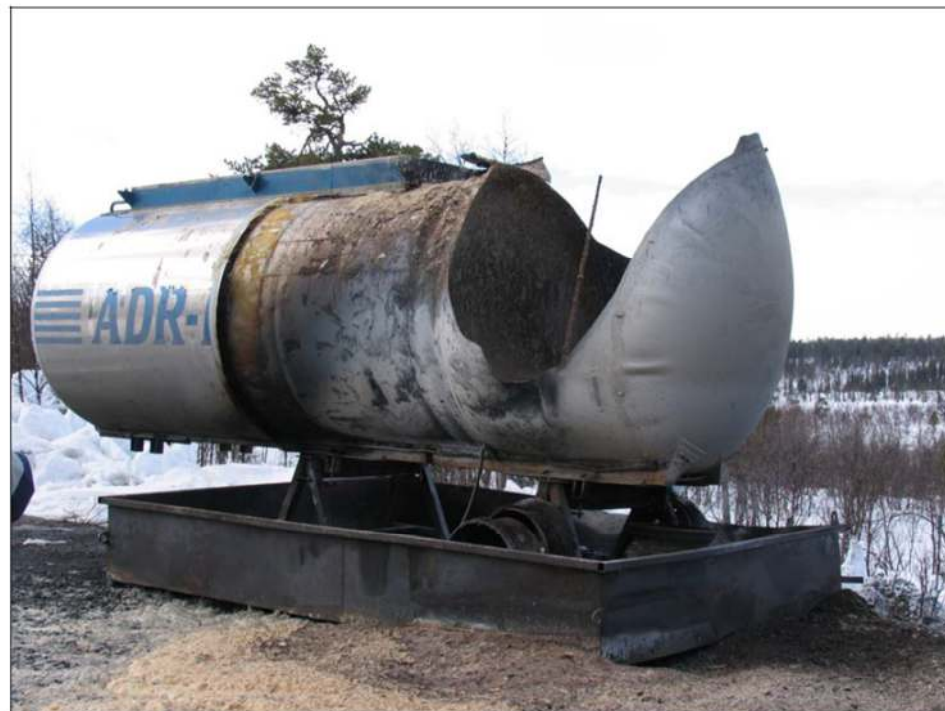
## Kuosanen ANE Fire test in SS tank (2007)

Figure 15, shows the ruptured stainless steel tank after the fire test. The rod is connected to the bottom valve and is a part of the tank.

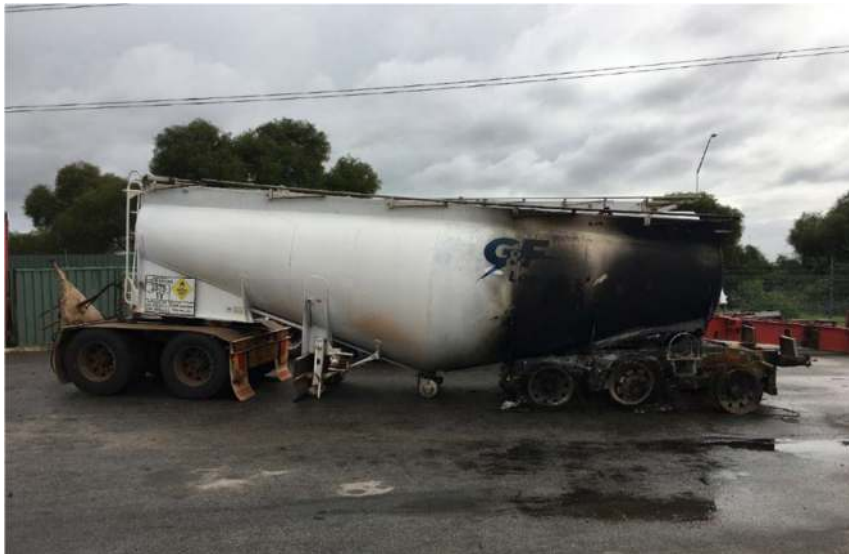
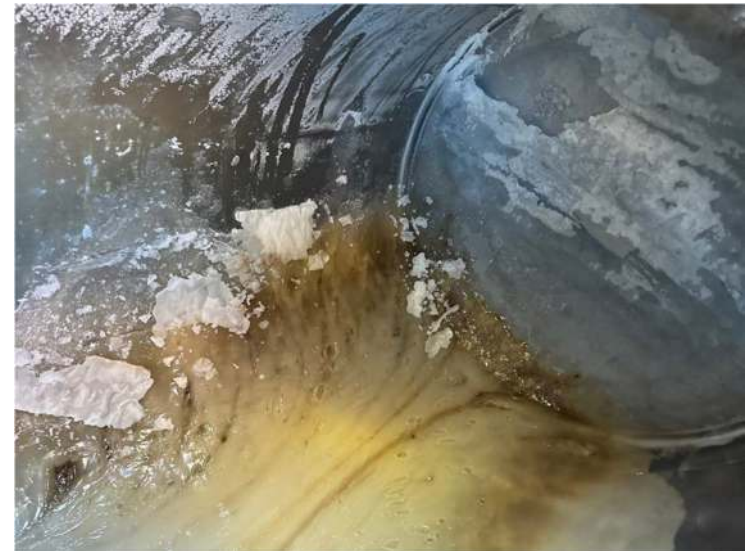
## 7.5 Tanker trailer fire – New Norcia, Western Australia, 2023; from the report

When the hatch of the tanker was opened in the morning, the ANE within the tanker was approximately 40 °C, slightly discoloured and the viscosity had decreased due to the separation of some of the emulsion into its liquid components. When the product was transferred out of the tanker a thin layer (about 1 mm thickness) of solid AN was observed on the inner surface. The formation of solid AN was limited to where the ANE was in direct contact with the tanker shell and closest to areas that had received prolonged direct heating by the fire (Figure 7.4).

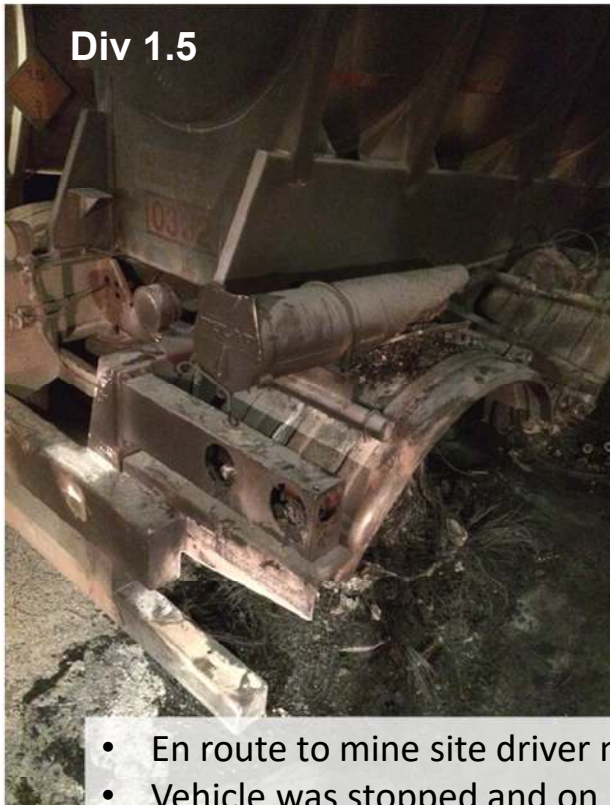
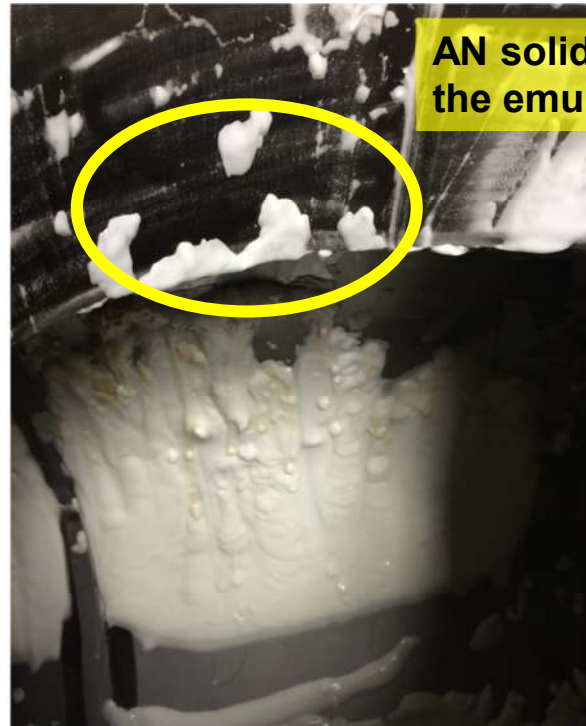
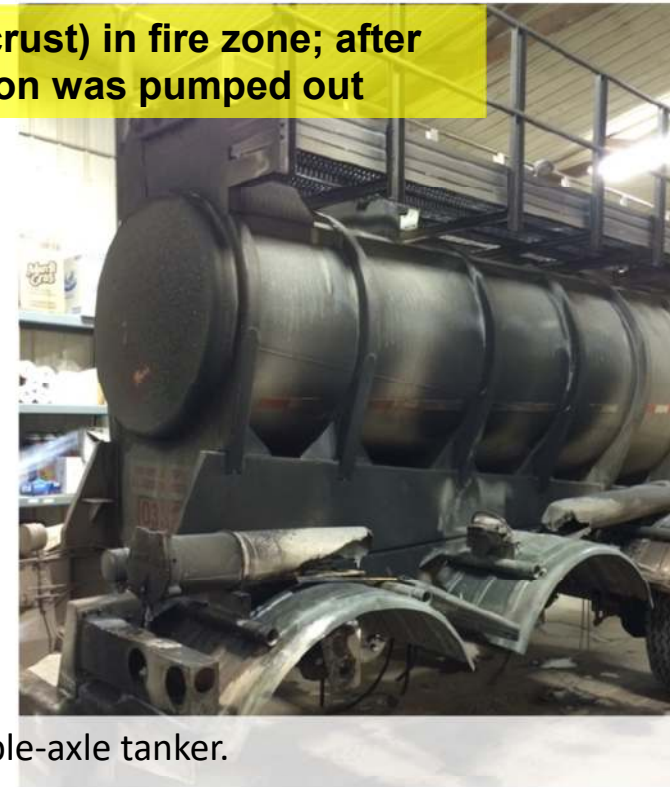
## TRANSPORT FIRE INCIDENT – USA

- En route to mine site driver noticed sparks underneath rear axles of triple-axle tanker.
- Vehicle was stopped and on investigation flames were visible
- Three fire extinguishers were used but fire persisted
- Tractor was disconnected from trailer; traffic diverted from scene, and evacuations to 1-mile area carried out
- Fire consumed all six tires on the passenger-side, air-hoses, lights and wiring, and melted the aluminum rims.
